STATENS BRANDINSPEKTION

Meddelanden

1958:5

Räddningslinor.

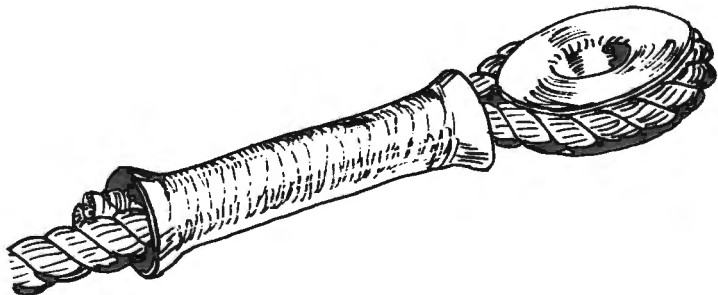
I det nu aktuella fallet har bristningen uppenbarligen haft samband med sättet för åstadkommande av den ögla, i vilken ändkausen är fastsatt.

På den brustna linan hade det erforderliga ögat istället för den sedvanliga ögonsplitsen åstadkommits med hjälp av en över linans båda parter trädd och därefter ihopklämd aluminiumhylsa. (se fig.)

Linbrottet skedde inne i aluminiumhylsan.

Utöver den direkta risk för linbrott även på en ny lina, som att döma av det inträffade föreligger, så torde vid en dylik konstruktion särskilt stor risk föreligga för okontrollerbara angrepp av mögel eller röta och därav följande fortlöpande försvagning av linan.

While being tested for acceptance at a certain Fire Brigade, a new Life Line broke already at a strain of a couple of cwt. It was not spliced in the usual way at the running eye, but the rope end constricted and secured, as shown in the figure, by means of a piece of compressed aluminum tubing. The rope broke inside this fixture.

In addition to the possibility of concealed mechanical damage, the aluminum tube is likely to enhance - and conceal - damage by mould and rot. Consequently, the Fire Brigades are warned against such a dangerous device, and if already in possession of lines fitted in this way, they had better be refitted by splicing in the usual way. And any new methods should evidently not be adopted until thoroughly ensured by adequate tests that they are not life-endangering.

Linor med den ovannämnda anordningen bör ej få finnas på brandkårerne. I den mån de förekommer bör anordningen med aluminiumhylsan omedelbart utbytas mot en konventionell splits. Med hänsyn till frågans stora betydelse ur säkerhetssynpunkt bör i fortsättningen ej heller anskaffas eller brukas andra liknande anordningar, innan de genom omfattande prov visat sig vara ur alla synpunkter fullt tillfredsställande.
