INVESTIGATION REPORT ON THE MGM GRAND HOTEL FIRE

**Las Vegas, Nevada
November 21, 1980**

Prepared by
RICHARD BEST
NATIONAL FIRE PROTECTION ASSOCIATION

DAVID P. DEMERS, P.E., DEMERS ASSOCIATES, INC.
CONSULTANT TO NFPA

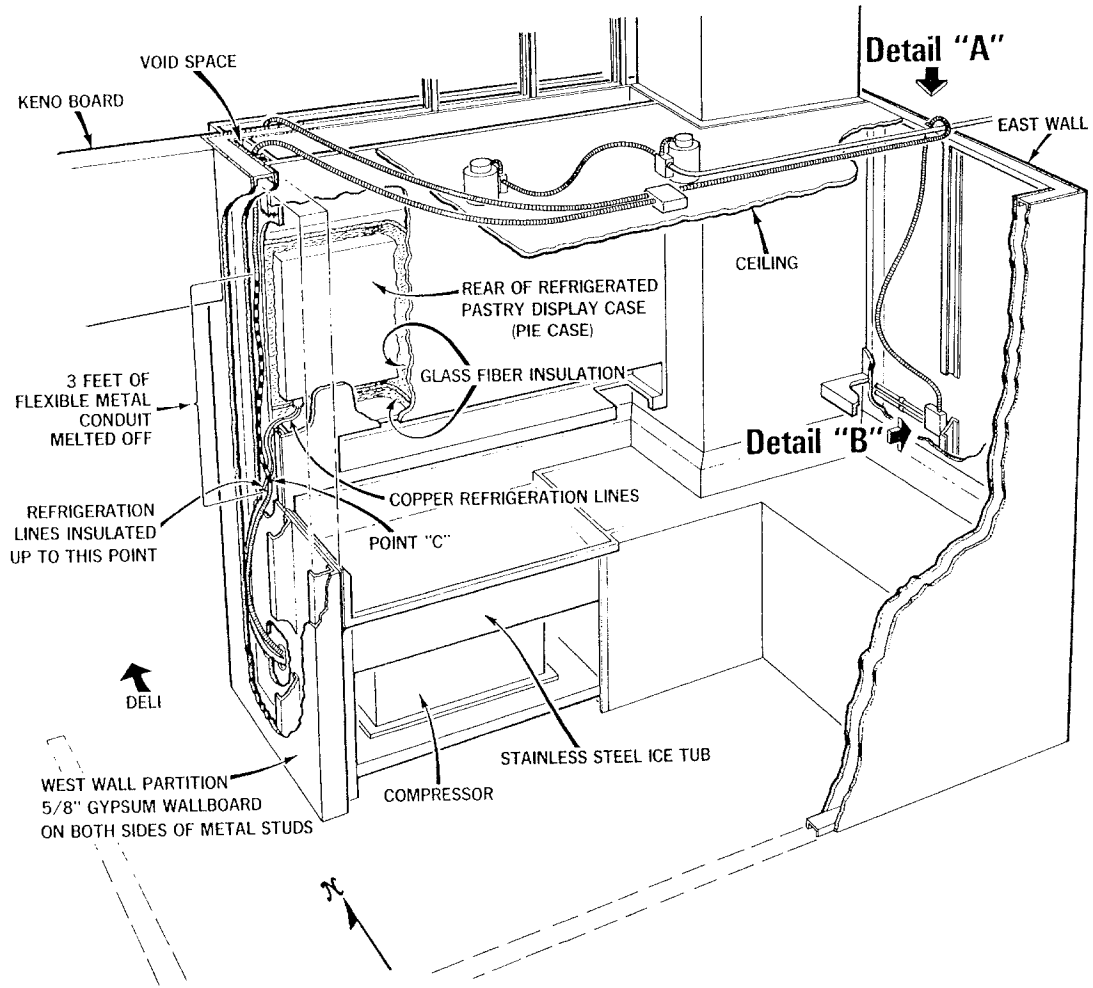
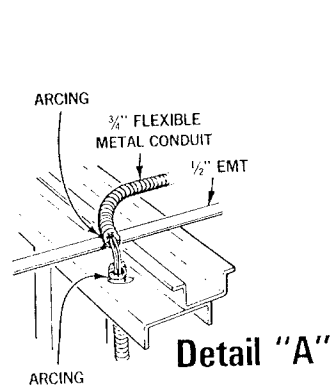
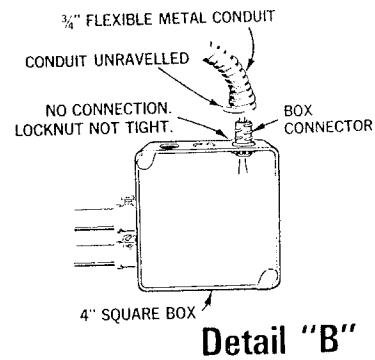
Figure 20. The Deli serving station.

the flexible metal conduit to the ½-inch electrical metallic tubing at the serving station east wall where arcing between the ½-inch electrical metallic tubing and the ¾-inch flexible metal conduit took place. (See Figure 20, Detail "A".) Further arcing and heating took place where the flexible metal conduit passed through the horizontal metal framing member. The length of the flexible metal conduit between the ground-fault point and the point of contact between the flexible metal conduit and the ½-inch electrical metallic tubing was approximately 16 feet.

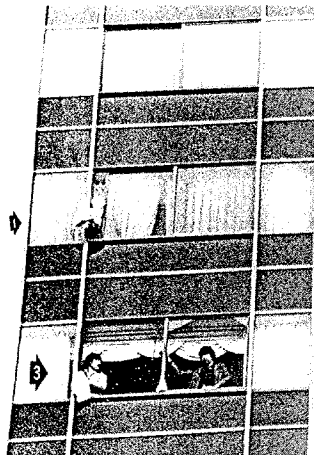
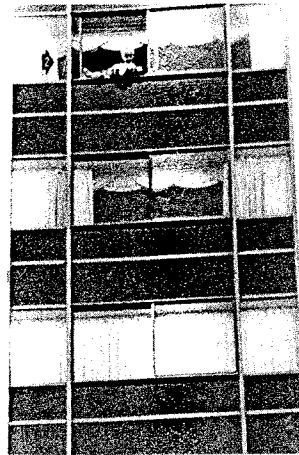
View of guests at windows shows variety of window conditions. (1) Window open to stop was extent of operation without removing stop. (2) Window open to stop, glass removed. (3) Window closed and two glass lights broken. (Credit: Las Vegas SUN)

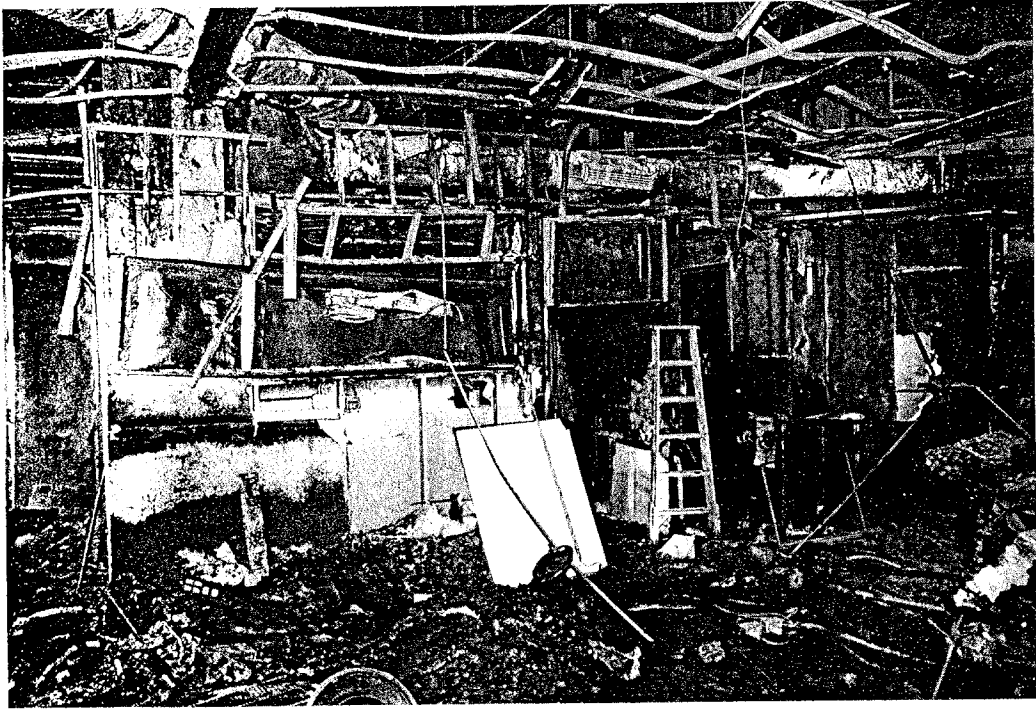
View of serving station in The Deli looking south. Note opening to serving station left of step ladder, Keno board above opening, pie (pastry) case left of opening. (Credit: NFPA)

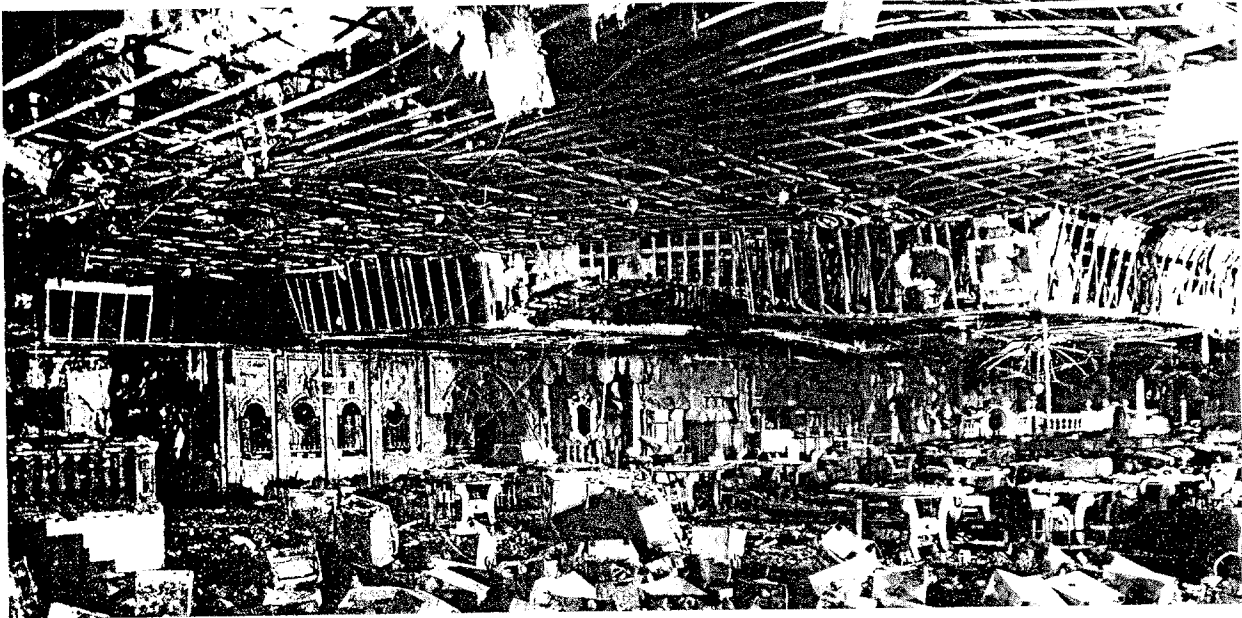
Looking toward southwest in Main Casino, damaged slot machines are at bottom of photo. the eye in the sky was the lower ceiling section. (Credit: Las Vegas Metropolitan Police Dept.)

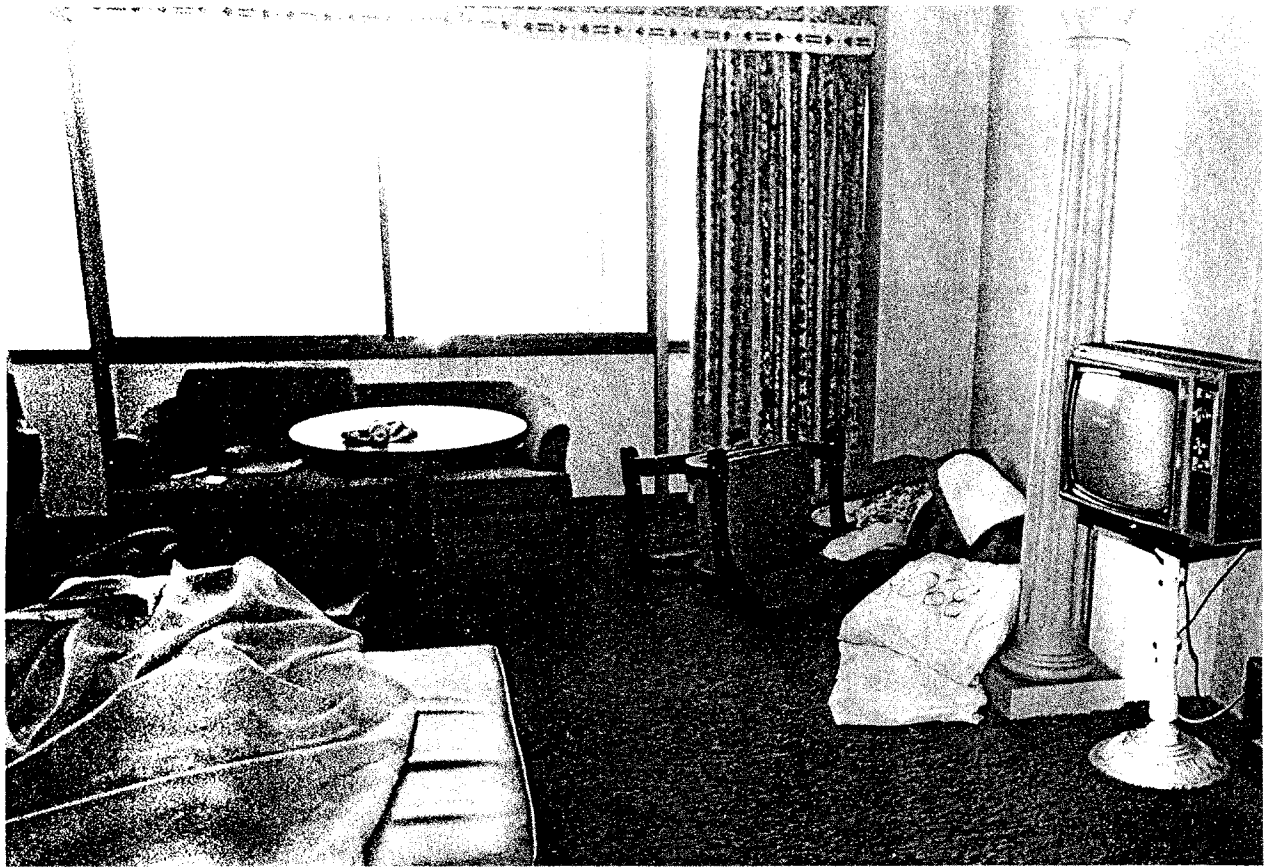
Room 2068 (adjacent to elevator lobby on 20th floor) where male victim was found next to open window in tipped-over chair. Room is typical of guest rooms throughout hotel with little evidence of smoke or soot particles. Window noted open to stop in earlier photo showing victim. (Credit: NFPA)

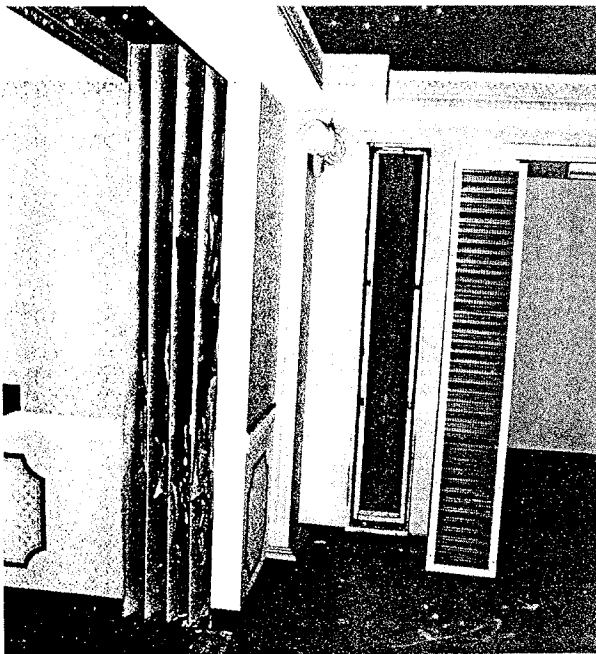
In high-rise tower, note air transfer grill fire damper unit removed and accordion fold metal at seismic joint. (Credit: NFPA)

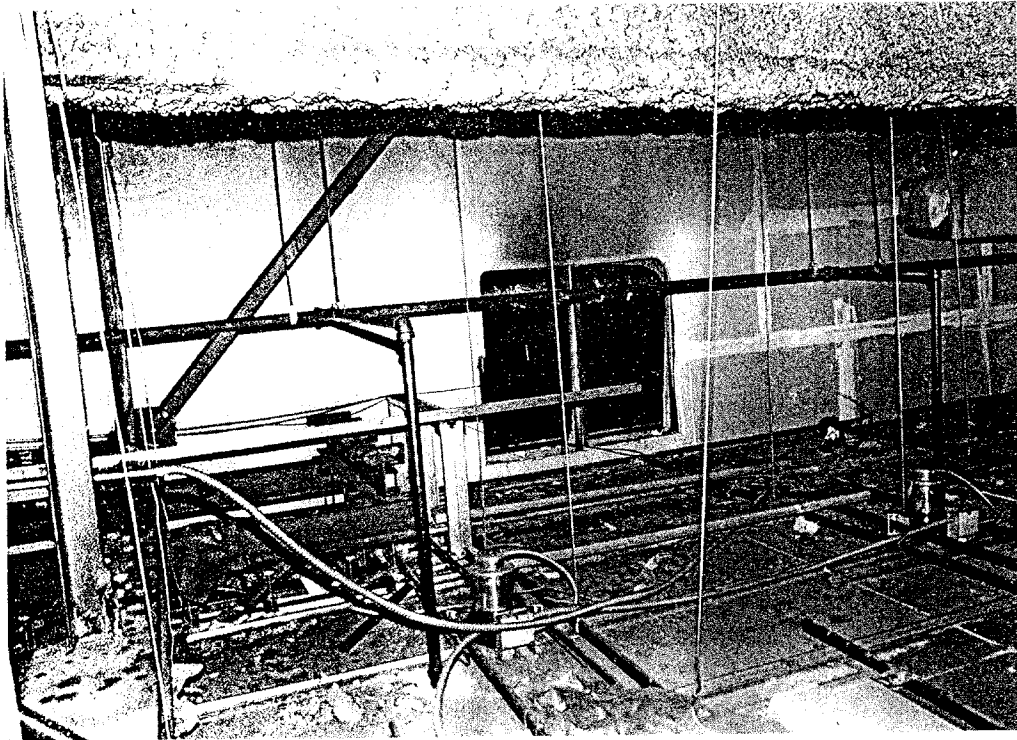
View of opening in partition above Casino level ceiling; ceiling space above Hall of Fame is on other side of partition. Photo taken near E1 stair. (Credit: NFPA)

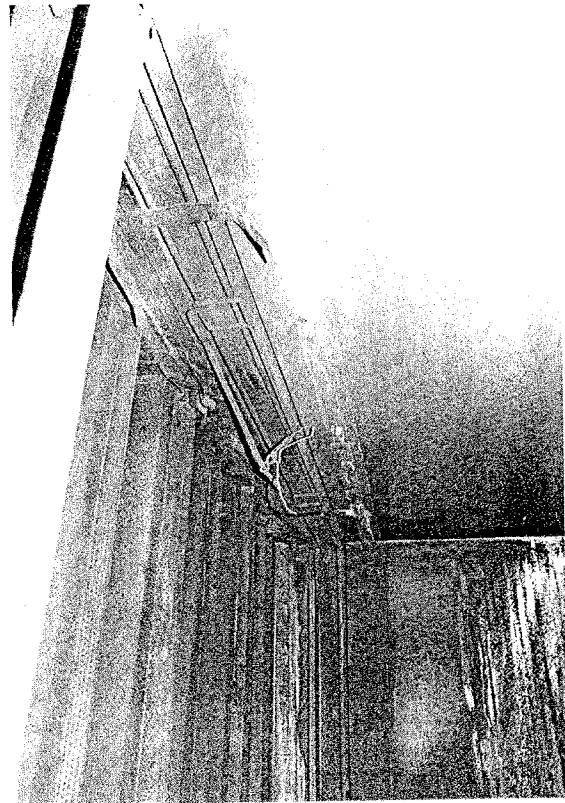
to various penetrations in the enclosures. Fire dampers were provided in the supply ducts and return air control assemblies where they penetrated the mixing room walls above the Casino ceiling. The automatic (fusible link-activated) function of fire dampers for two return air control assemblies had been impaired prior to the fire in the easternmost mixing room. This was done by bolting steel straps across the dampers so they could not close. In addition, it was noted that several dampers had fusible links replaced with steel wire.

View of fire damper with straps arranged to prevent damper from closing. (Credit: NFPA)

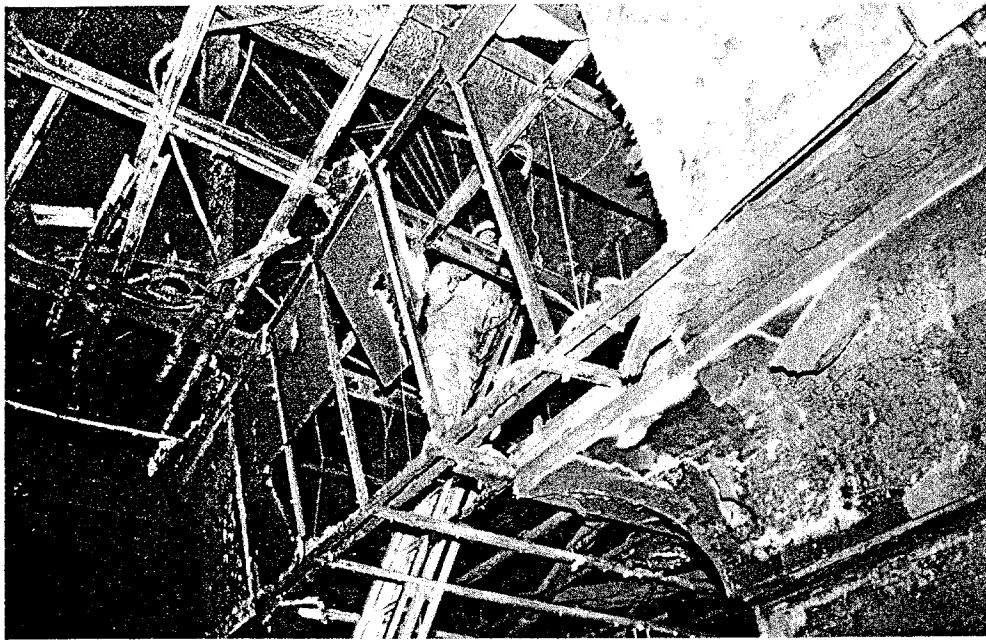
View from the Casino level shows fire investigator on ladder in concealed space directly beneath the base of W2 stair. (Credit: NFPA)

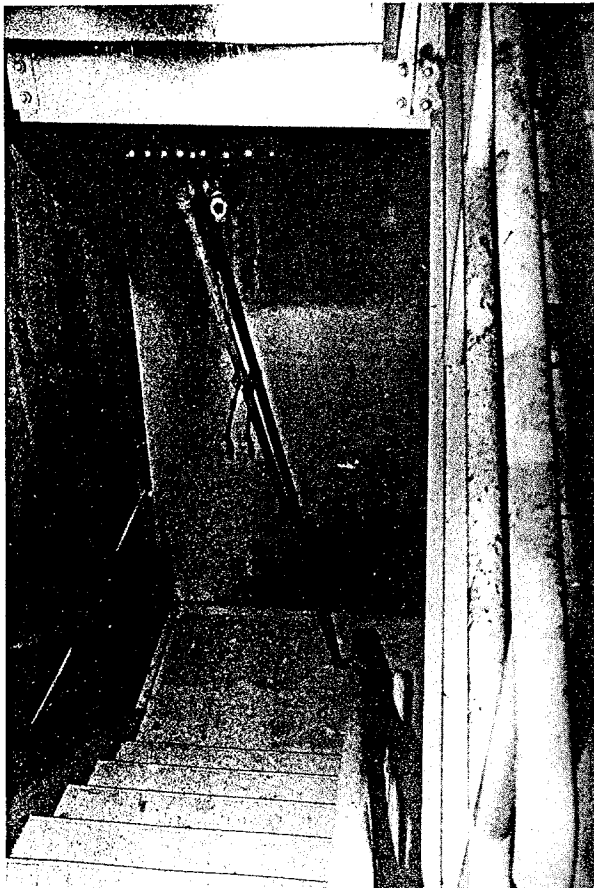
From about the 5th floor landing looking down S1 stair toward exit passageway. Note collapsed sprinkler piping. (Credit: NFPA)

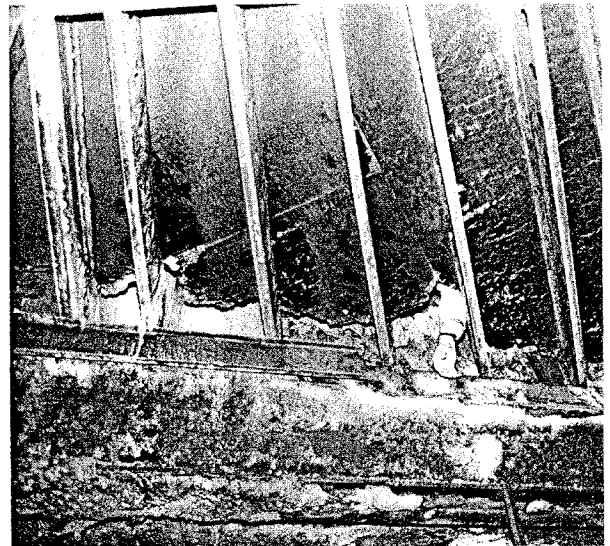
The E2, S2 and W2 stairs were smokeproof towers, consisting of stairways connected to the floors by exit vestibules. The vestibules were vented directly into smoke shafts that terminated at the top of and within the stair shafts. The smoke shafts were naturally vented directly to the outside. Many of the vents from the smoke shafts were covered by exterior sheathing of the building. It was further noted that the bottom of the W2 smoke tower, which was exposed to the concealed space above the Casino level, was sheathed in plywood. A plywood base also existed in the E2 stairway.

View from concealed space above Casino level ceiling looking at plywood deck of the S2 smokeproof tower air shaft. Note investigator's arm extending through gap where plywood is burned away. (Credit: NFPA)

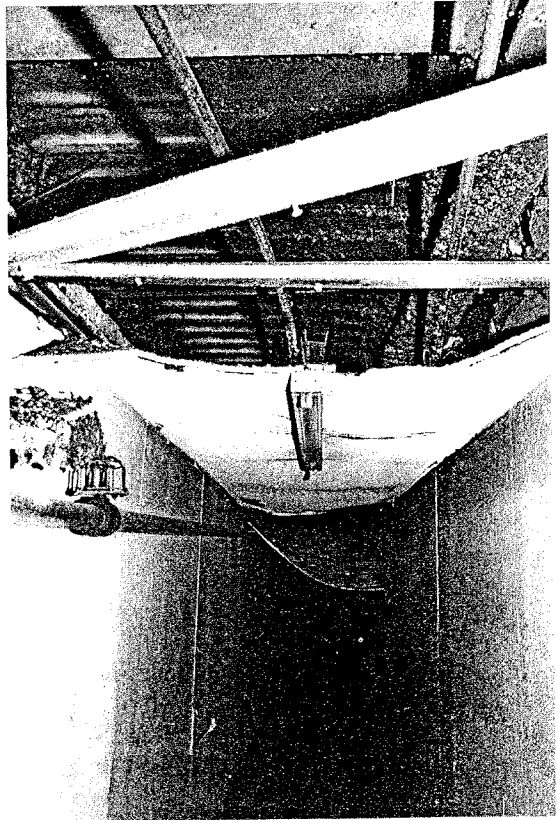
Exit passageway from S1 stairway, note single thickness gypsum wallboard ceiling and sprinkler piping pulled from ceiling (Credit: NFPA)

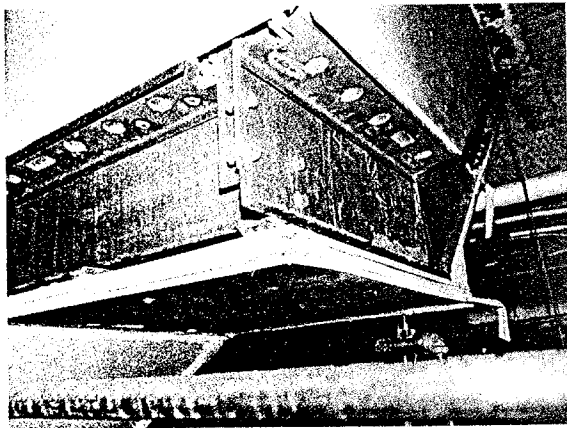
and one layer of 5/8-inch gypsum wallboard for ceilings. In many places the enclosures were not complete which resulted in spaces of approximately 5/8 inch in width running the entire length of the stair stringers. In addition, in many locations fire protection for the steel components of the stairs was nonexistent. (See Photo top left, page 57.) These spaces, along with the lack of fire-resistance protection for the stairs, openings covered with nonrated sheet metal access panels into the stairways and exit passageways and insufficient quantities and thickness of gypsum wallboard, resulted in inadequate protection of stairways and exit passageways. These deficiencies were confirmed for the S1, W1, and E1 stairways.

View of stairway EI base from the concealed space above Casino level ceiling. Note lack of protection of steel members and openings to stair interior. (Credit: NFPA)

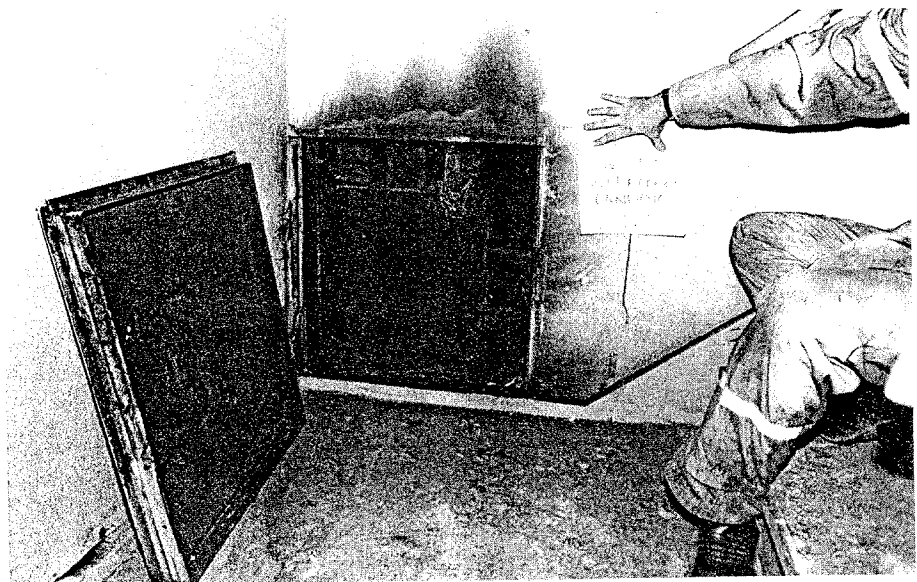
View is from stair W1 interior looking at access opening to concealed space above Casino. Note heat damage and soot pattern from smoke exposure. (Credit: NFPA)
