INVESTIGATION REPORT ON THE MGM GRAND HOTEL FIRE

**Las Vegas, Nevada
November 21, 1980**

Prepared by
RICHARD BEST
NATIONAL FIRE PROTECTION ASSOCIATION

DAVID P. DEMERS, P.E., DEMERS ASSOCIATES, INC.
CONSULTANT TO NFPA

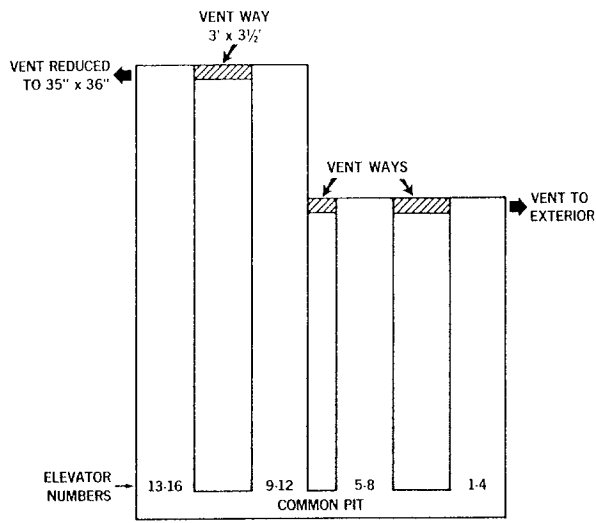
Figure 10. MGM passenger elevator hoistway arrangement.

The venting of elevator hoistways is indicated in Figure 10. The common hoistway for passenger elevators P1 through P4 was vented directly to the exterior on the north face of the building. The low-rise elevator hoistway for elevators P5 through P8, which was back-to-back with the high-rise hoistway for elevators P9 through P12, was vented into the high-rise hoistway and also to the P1-P4 hoistway.

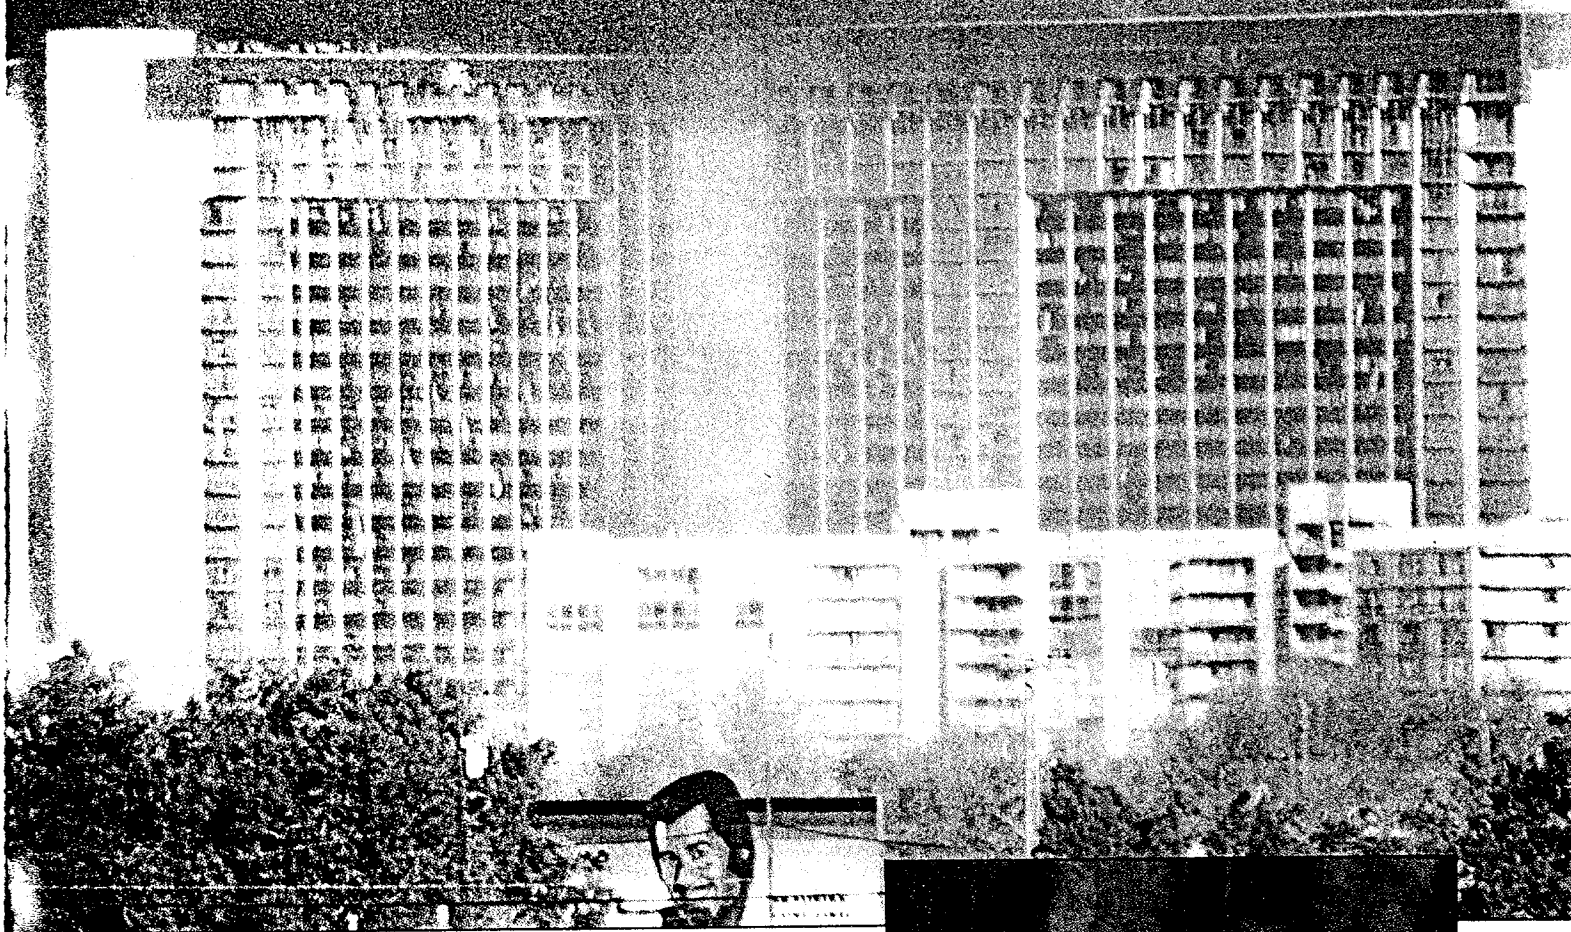
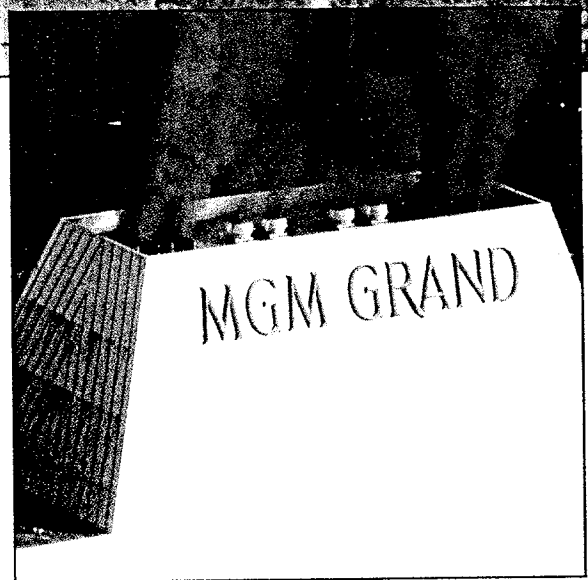
TOP: 7:40 am. View from southeast shows occupants on roof of south wing. INSET: Smoke vents activate on roof of fly gallery of MGM's Ziegfeld Room. (NOTE: The times in this series of color photographs were estimations by the photographers.)

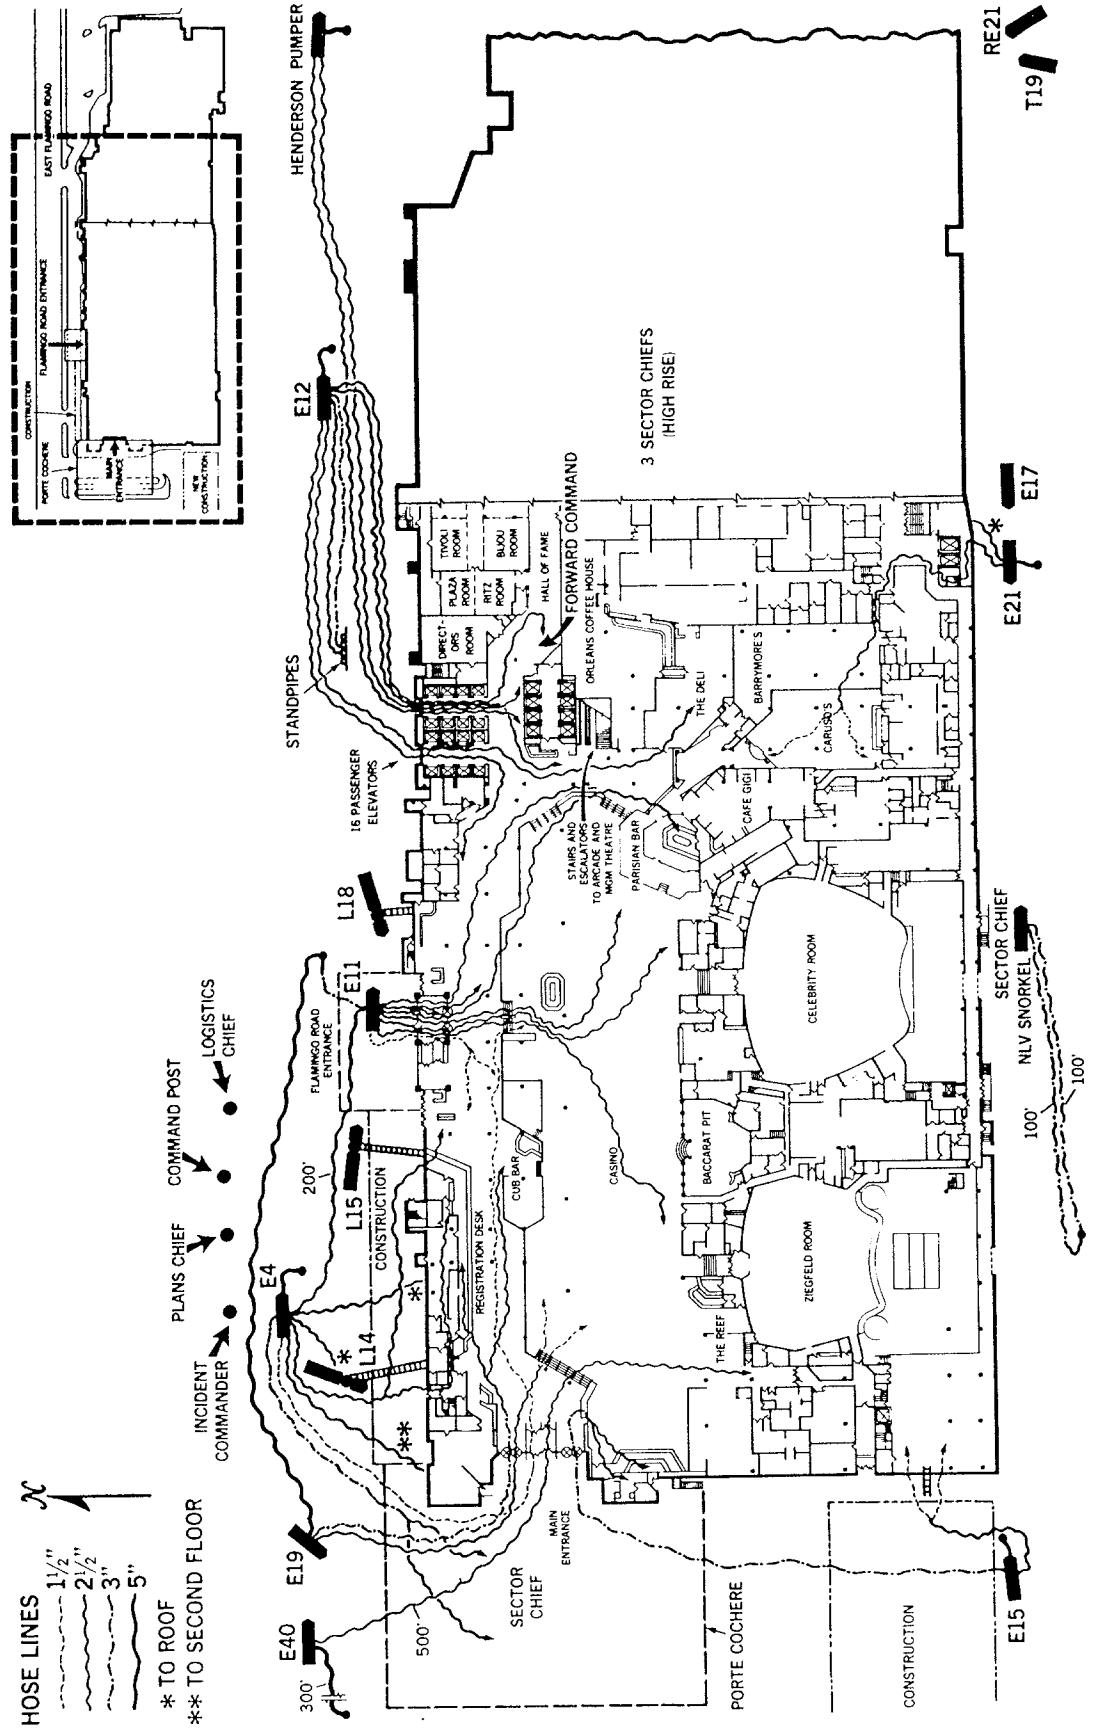
Figure 13. Fire suppression drawing. (Above — area shown in detail)

handlines with either 3-inch lines wyeed to two 2½-inch or directly to 2½-inch handlines. An example of the heavy reliance on well-positioned pumpers is Engine 11 which supplied seven 2½-inch and two 1½-inch handlines through the north entrance. (See Figure 13.) Water supply in the rear (south side) of the building was adequate with only two engines supplying the limited needs in this sector.

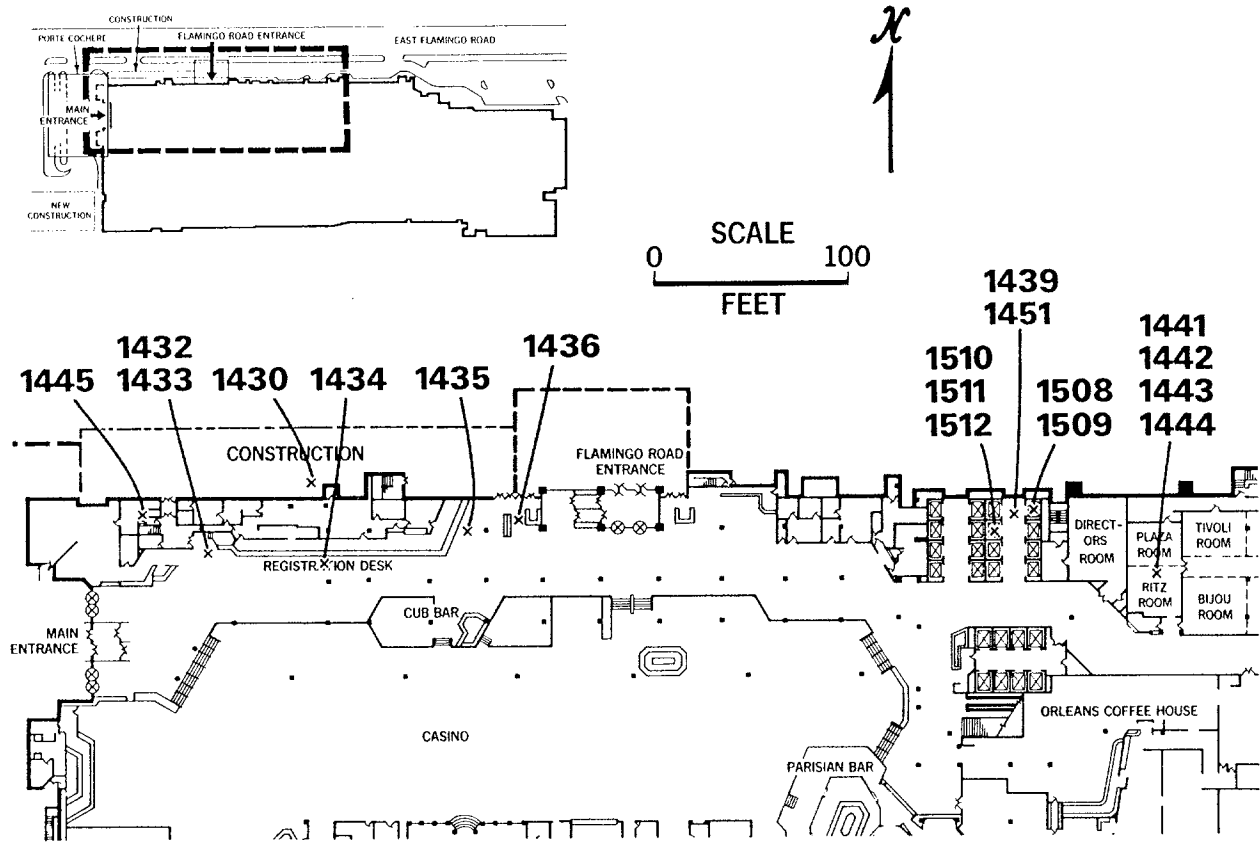
Figure 17. Casino level fatality locations. (Above — area shown in detail)

The locations of 18 victims on the Casino level are shown in Figure 17. Six victims were found in the Registration Desk area; three of these victims (case numbers 1433, 1434, and 1436) had extensive body surface burns in addition to smoke and carbon monoxide inhalation. It appears that these victims were overrun by the flame front moving through the Casino. Four victims were found in the Ritz Room, five in elevators and two victims were found in the Casino level elevator lobby. One victim (case number 1430), previously discussed, died of a massive skull fracture when she either jumped or fell from the high-rise tower.

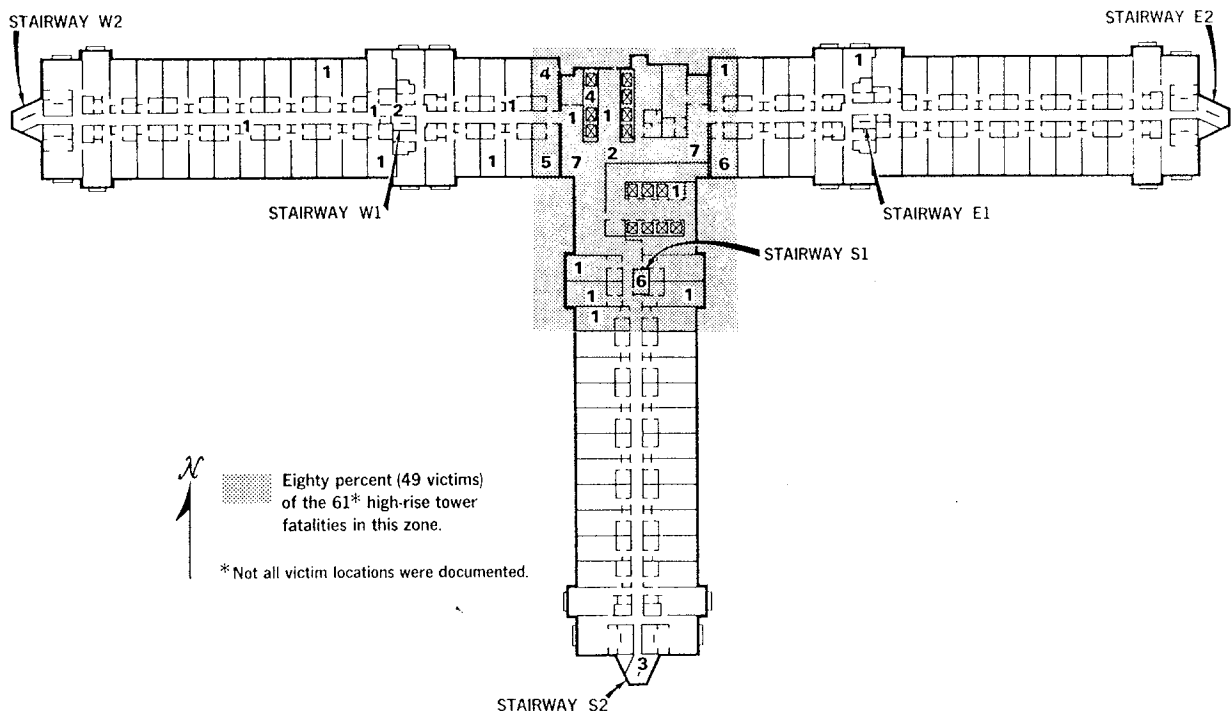
Figure 18. The numbers on this figure indicate victim totals in approximate locations on nine floors. (Floors 16 through 26 — see also Figures 14 through 16 and Table 3.1)

located predominately in rooms and corridor areas between the interior stairs and central core areas on nine floors. (See Figure 18.) On the 24th floor, eight victims were located in the central core. Figures 14, 15, and 16 show location details; victims are identified with Clark County Coroner case numbers. A summary of victim location data is presented in Table 3.1.

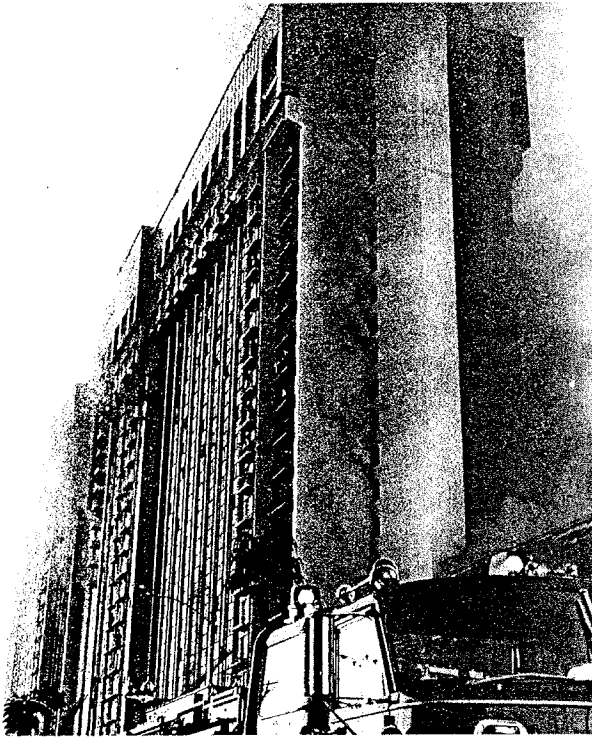
View from northwest early in fire shows smoke from upper floors and "smokeproof" tower, stair W2 (directly above apparatus cab). (Credit: Las Vegas News Bureau)

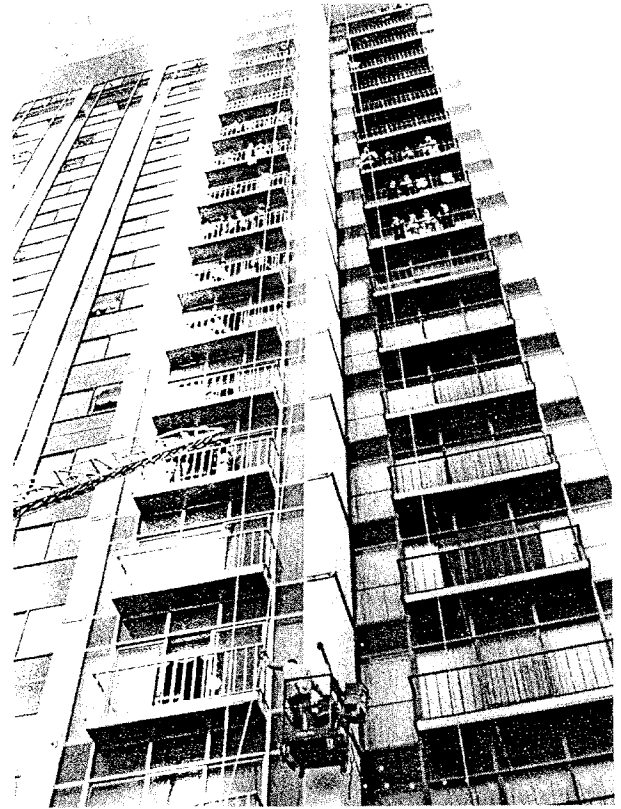
View of north face of hotel shows aerial ladder and construction hoist used to rescue some occupants. All but lowest (5th floor) guest room floors are shown. (Credit: Las Vegas SUN)

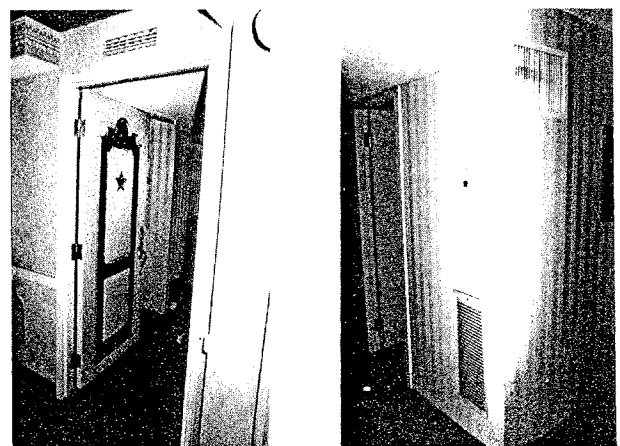
From corridor looking into guest room, fan-coil unit within room took make-up air from corridor through air inlet above door. Fan-coil unit in room delivered air to room (air outlet at top) taking make-up air from corridor and recirculating room air thru air inlet at bottom. (Credit: NFPA)
